Chapter 8 Specialized Repairs

8-1. Lock Wall Rehabilitation

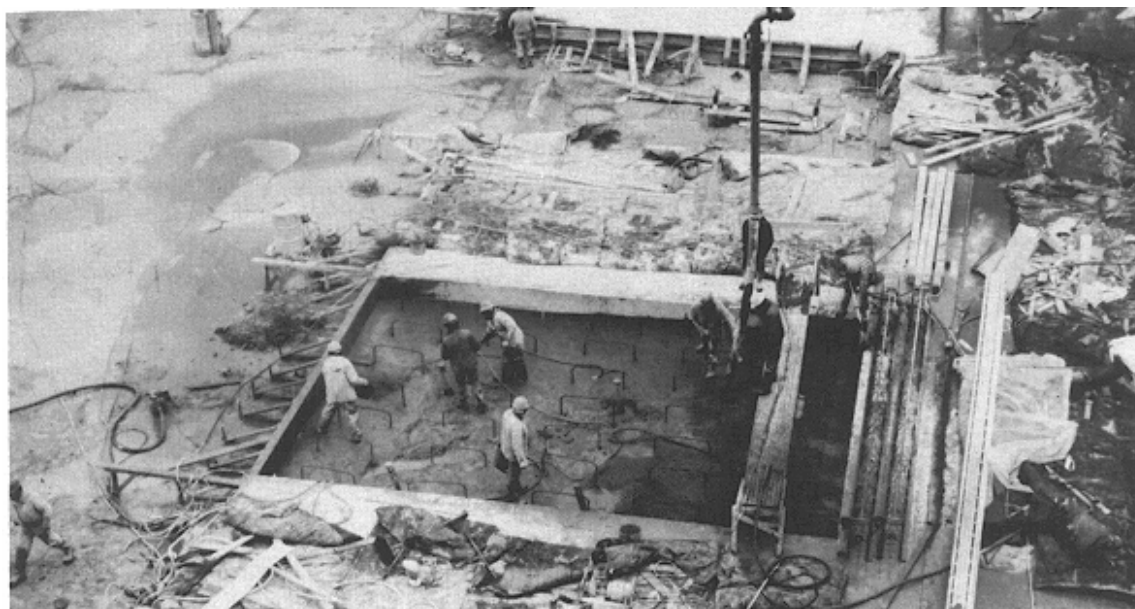
(9) Following dewatering and a thorough cleanup, the transit-mixed silica-fume concrete was pumped into the basin through approximately 46 m (150 ft) of 127-mm (5-in.) pump line (Figure 8-36). The concrete was consolidated with internal vibrators. Once the majority of the concrete was in the form, the screeding operation was started. The two vibrating screeds were connected in tandem with the second following the first at about a 1.5-m (5-ft) interval. Curing compound was applied immediately after the second screed passed over the concrete.

(10) Although the placements generally went well, there was a problem that arose during the construction: cracking of the silica-fume concrete overlay. The widths of cracks were from 0.25 to 0.51 mm (0.01 to 0.02 in.) and usually appeared 2 to 3 days after placement. The cracks were attributed primarily to restraint of volume changes resulting from temperature gradients and, possibly, autogenous shrinkage. Several approaches, including applying insulating blankets over the concrete, saw cutting the slab after placing to establish control joints, and addition of reinforcing steel mat, were attempted to stop or minimize the cracking; however, no solution was found for the cracking problem. The cracks were not repaired because laboratory testing of cracked specimens indicated that fine cracks do not affect abrasion resistance.

Figure 8-36. Pumping silica-fume concrete into the stilling basin from the top of the right training wall, Kinzua Dam

(12) The potential for cracking of restrained concrete overlays, with or without silica fume, should be recognized. Any variations in concrete materials, mixture proportions, and construction practices that will minimize shrinkage or reduce concrete temperature differentials should be considered. Where structural considerations permit, a bond breaker at the interface between the replacement and existing concrete is recommended.

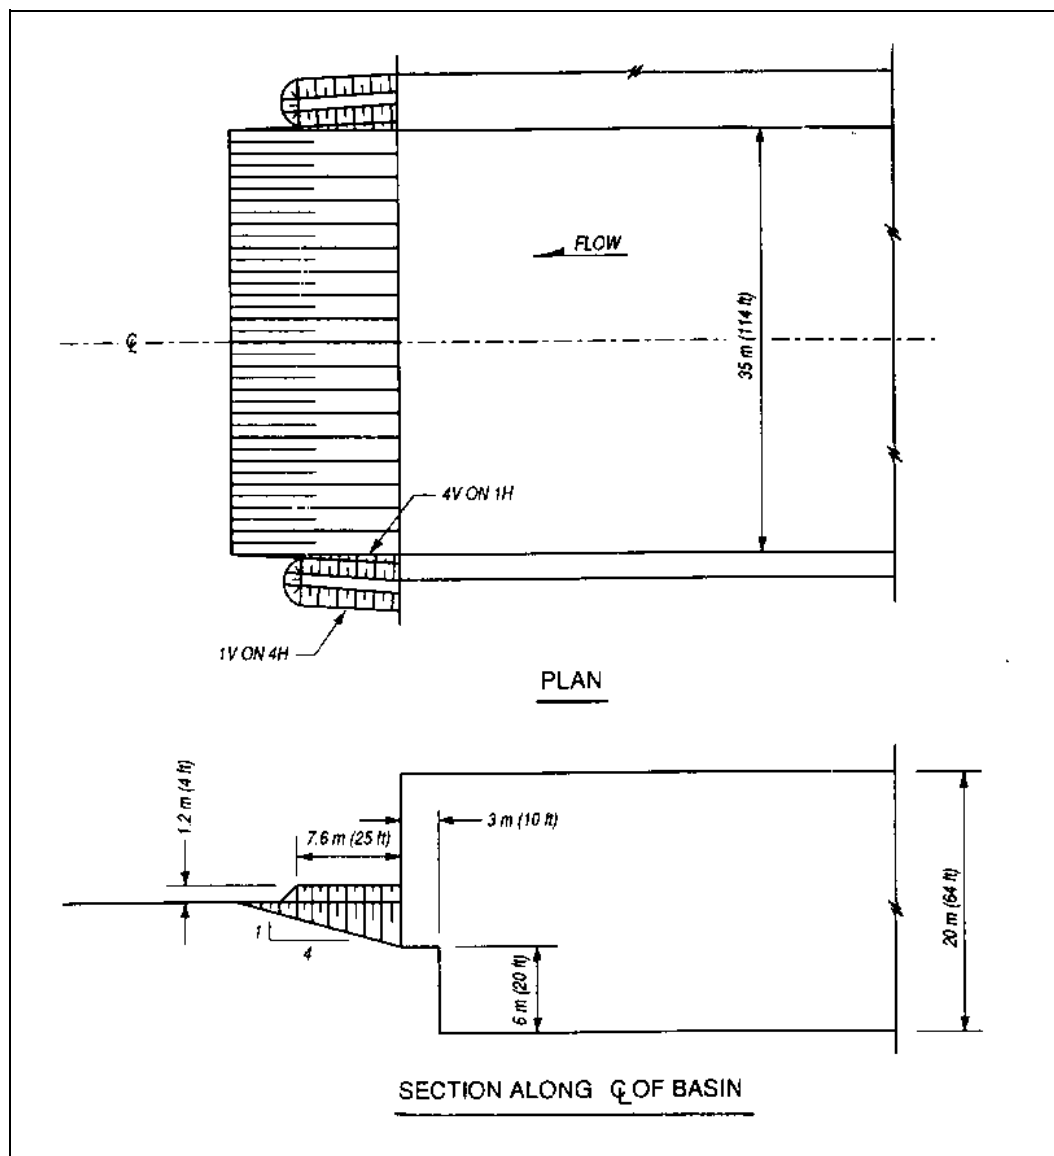
Figure 8-37. Stilling basin wall extension fills, Dworshak Dam

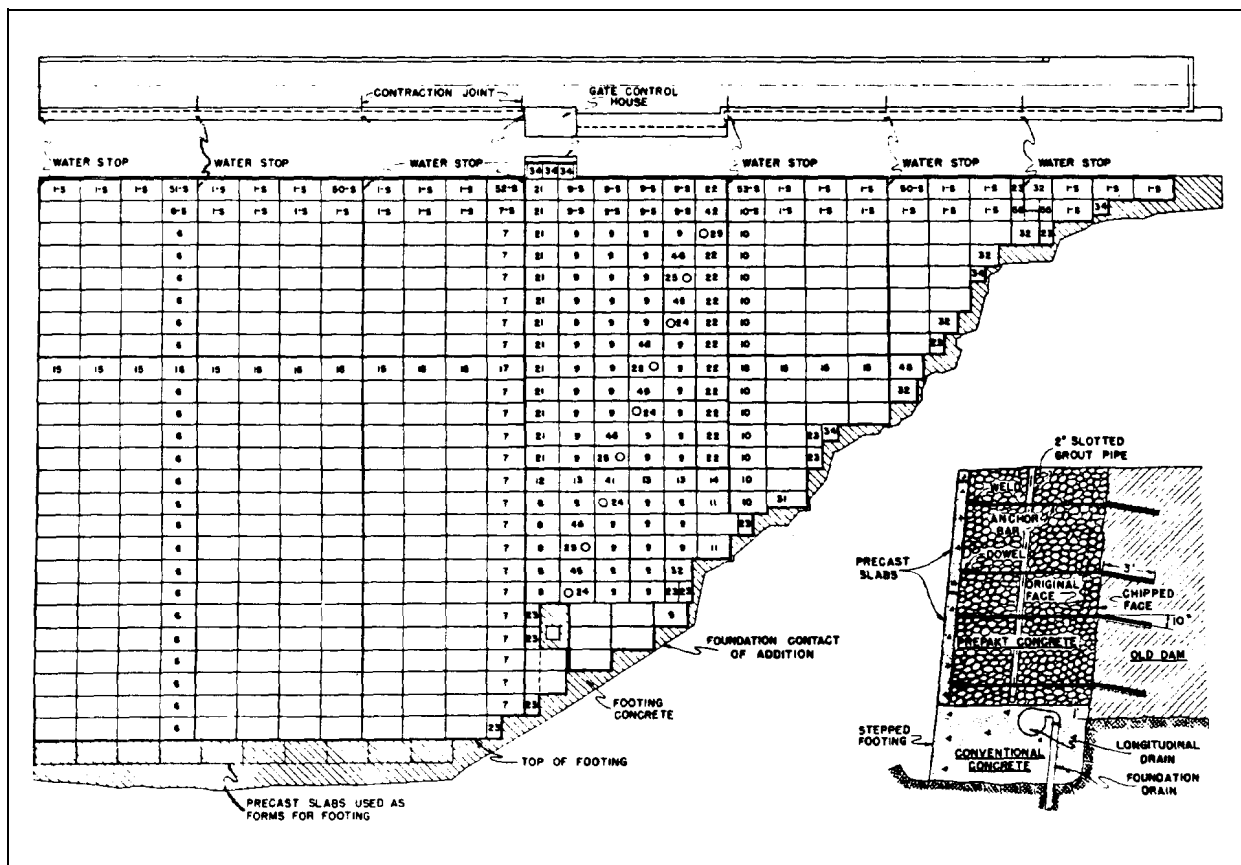
upstream face, placing coarse aggregate between the dam face and the precast panels, and then grouting the aggregate (Figure 8-38). Several factors influenced the decision to select this repair method, including: (a) repair had to be completed between the time the reservoir was emptied in the fall and filled in the spring, (b) precast panels and aggregate could be placed in severe winter weather conditions, (c) precasting the panels the summer prior to installation and placing them during the winter reduced the potential for later opening of construction joints, (d) a grout with a low cement content could be used for the preplaced aggregate to minimize temperature rise, providing there was a protective shell of high-quality precast concrete, and (e) precast panels were not as expensive as the heavy wooden forms necessary for the placement of conventional concrete.

Figure 8-38. Footing and slab layout, south half of Barker Dam (from Davis, Jansen, and Neelands 1948)

203 mm (8 in.) thick and most of the panels were 2.1 m (6.75 ft) wide by about 3.7 m (12 ft) long and weighed about 3,630 kg (4 tons). Prior to panel installation, deteriorated concrete was removed from the upstream face of the dam, anchors were installed in the sound concrete, and a stepped footing of conventional concrete was constructed at the base of the dam. The panels were positioned on the dam with a crawler-crane, and dowels embedded in the panel during precasting were welded to anchor bars in the face of the dam. After the joints were grouted, placement of the aggregate was started. Grouting of the preplaced aggregate began when the water elevation was 4.6 m (15 ft) below the crest of the spillway and was completed in about 10 days with almost no interruption.

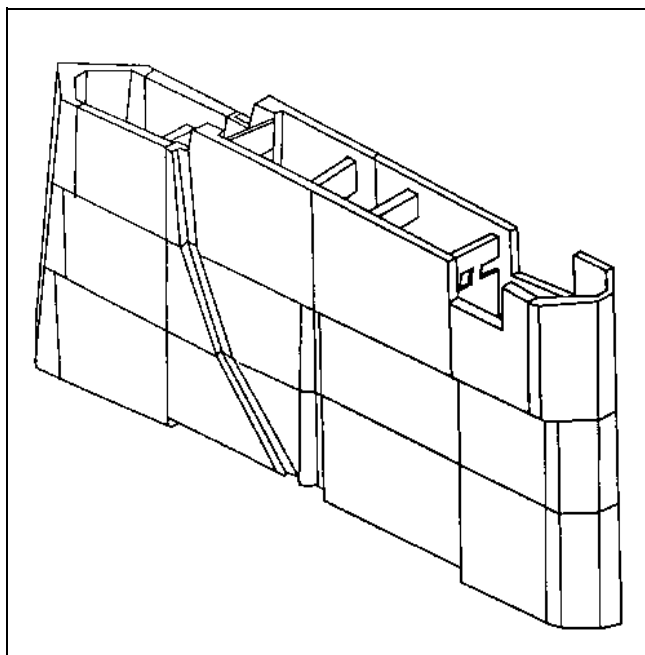
1993. In stage I, a cellular cofferdam was constructed to enclose piers 5, 6, and 7. Following dewatering, the counterweights for each tainter gate were removed and placed on temporary supports immediately downstream of the gates. The steel tainter gates were then removed for refurbishing and the existing concrete gate piers were removed down to the original foundation. Precast concrete units were used to reconstruct the gate piers (Figure 8-40).

Figure 8-40. Isometric view of gate pier 6, C-1 Dam

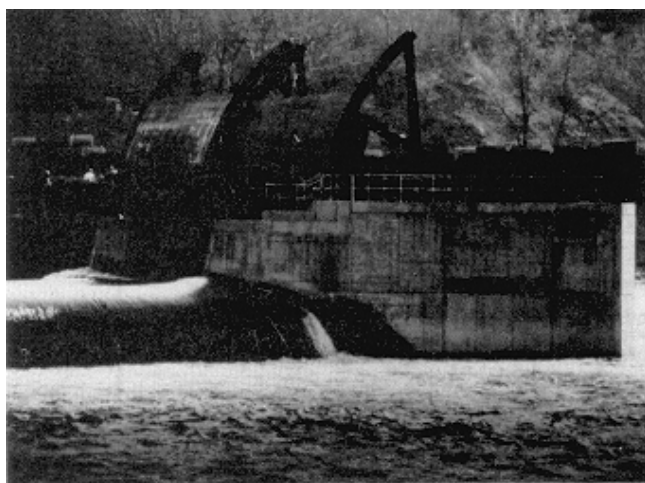
(2) The precast pier units were transported via tractor-trailer rigs to a launch ramp near the dam. At this point, the loaded rigs were driven onto a barge for transportation to the construction site in the river. The pier units were offloaded with a crane located on the cofferdam. A second crane inside the cofferdam was used to position the pier units. After each tier of units was properly proportioned and aligned, the vertical and horizontal joints were grouted, reinforcement was installed inside the units, and the units were filled with conventional concrete. Eighteen precast units were used in each gate pier. The completed piers are 2.4 m (8 ft) wide, 18.7 m (61.5 ft) long, and 8.7 m (28.5 ft) high. Following completion of the gate piers, the reconditioned tainter gates were reinstalled (Figure 8-41). A similar procedure is currently being used to reconstruct the four remaining gate piers.

Figure 8-41. Completed precast concrete piers with tainter gates reinstalled, C-1 Dam

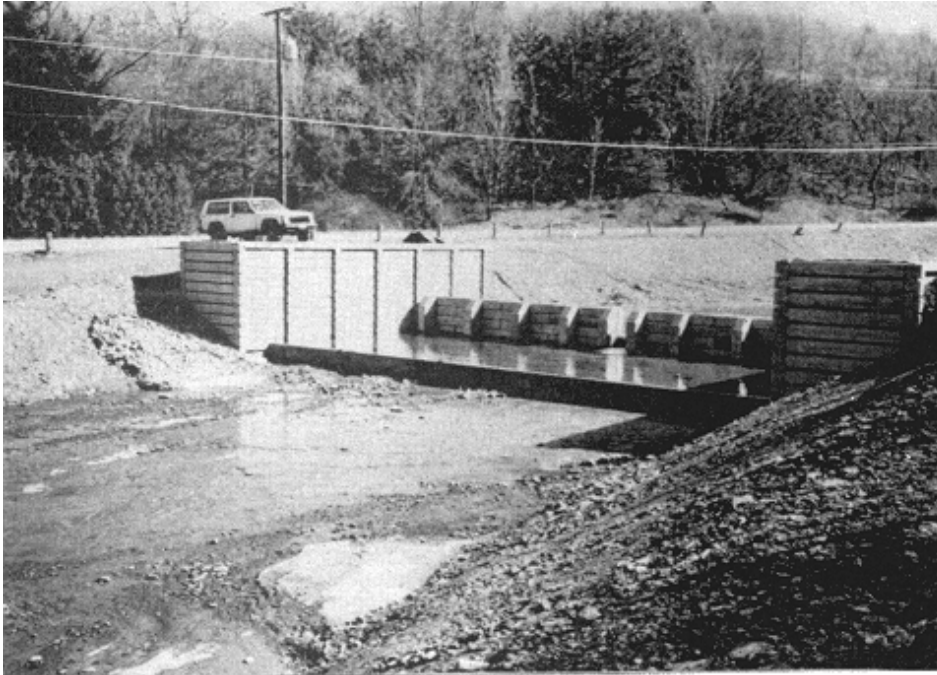
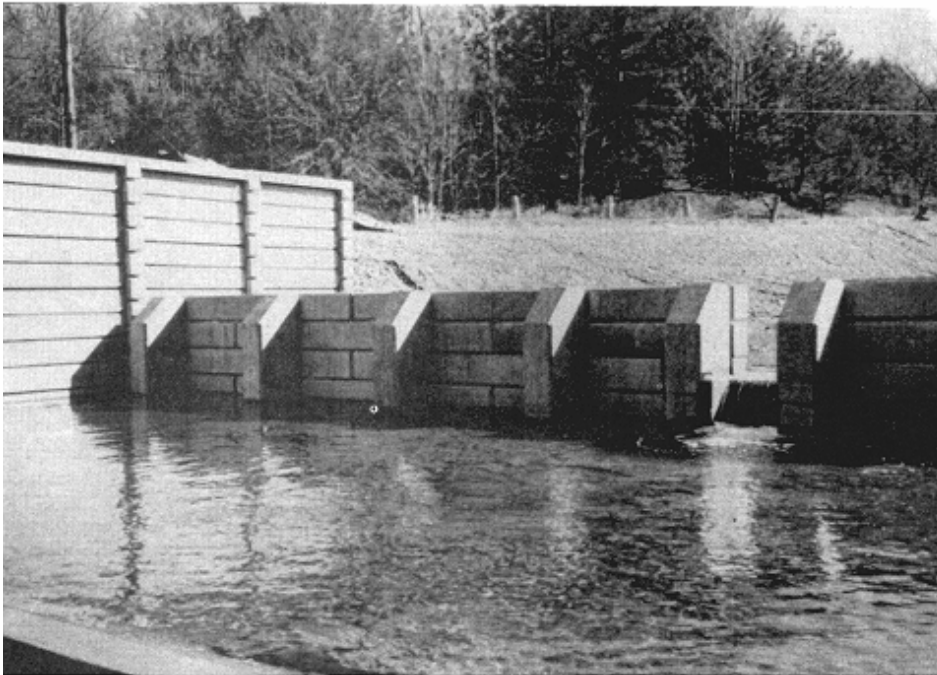
foundation (Figure 8-42). The use of precast concrete made it easy to maintain flows during construction, and the appearance of the new structures is well-suited to the site (Figure 8-43).

Figure 8-43. Precast concrete checkdams, Chauncy Run

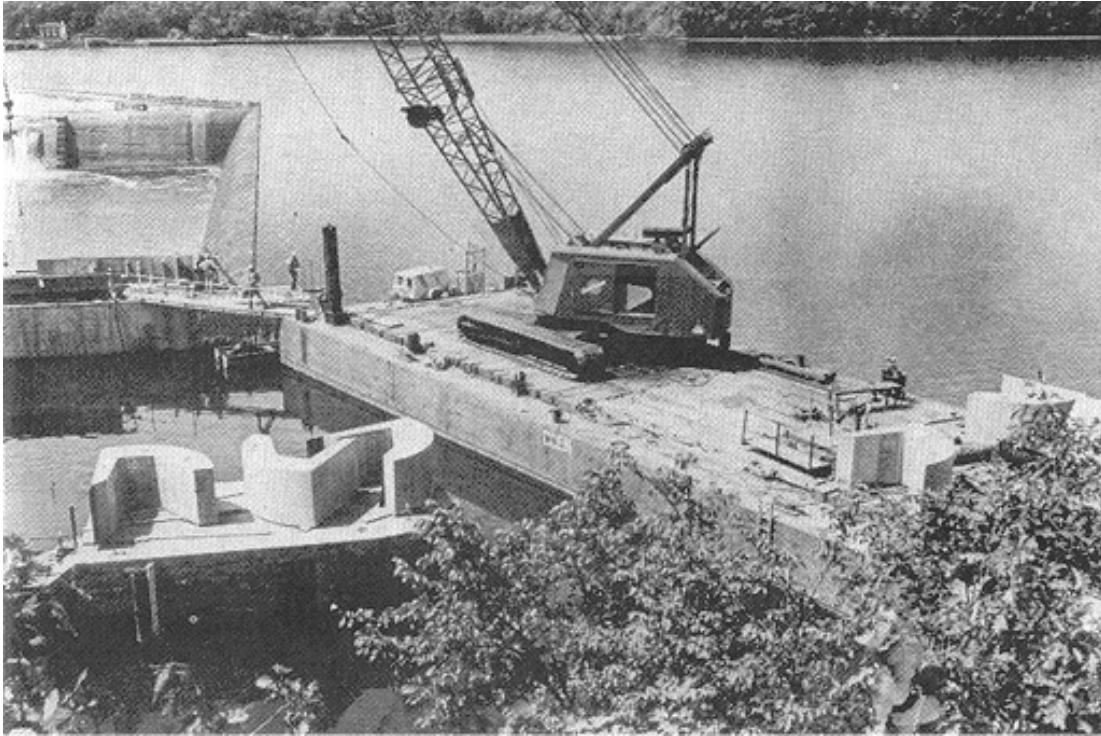
(1) The original design for the pier nose was based on cast-in-place concrete inside a dewatered cofferdam. However, the bid cost for the cofferdam alone was \$250,000, so the project team reviewed alternatives and decided to use six precast concrete sections stacked vertically with tremie concrete infill. Placement of the precast nose sections (Figure 8-44) and the tremie concrete required approximately 7 working days. The first section was positioned and leveled with jackposts, and sandbags were placed around the perimeter of this segment. Infill concrete was tremied to the top of this section and cured for 4 days. During this time, divers installed guide angles

Figure 8-44. Precast pier nose sections ready for underwater installation, Vischer Ferry Dam (Summer 1993)

and reinforcing dowels into the existing pier and spud pipes into the first section. Then, precast sections 2 through 6 were installed, and temporary intermediate connections were installed to resist plastic concrete loads during the second tremie concrete placement. Tremie concrete was placed to within 152 mm (6 in.) of the surface at a placement rate that did not exceed 3 m (10 ft) per hr. A cast-in-place concrete cap slab was then formed and placed.

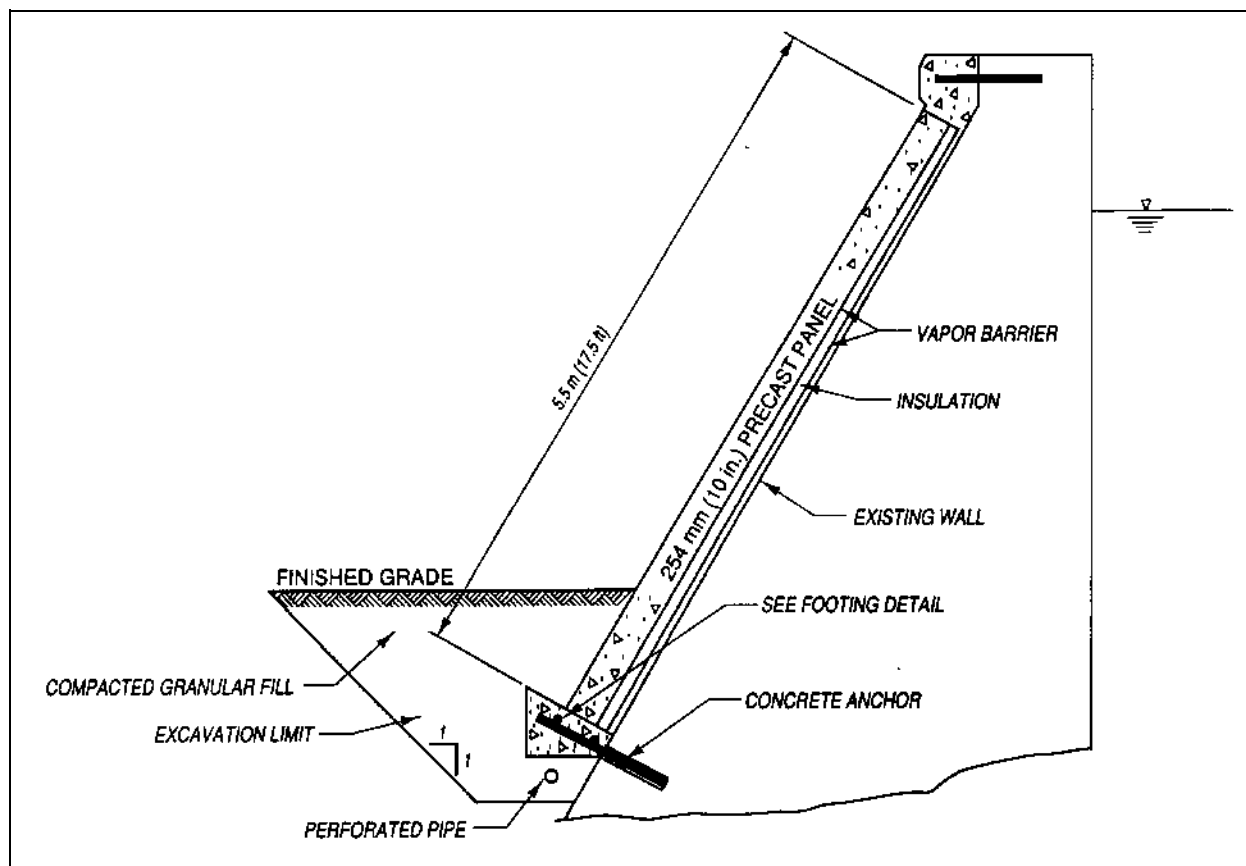
Figure 8-49. Typical repair section, Joliet Channel Wall

(1) A condition survey in 1984 revealed that seepage along monolith and construction joints combined with cycles of freezing and thawing had resulted in extensive deterioration of the exposed concrete to maximum depths of 0.6 m (2 ft). In contrast, those sections of the wall insulated from freezing and thawing by backfill had

escaped deterioration. Stability analyses, which considered the depth of deterioration, confirmed that the gravity walls founded on bedrock remained stable. Therefore, it was decided that any repairs should provide aesthetically acceptable insulation for the exposed concrete walls to

reduce the potential for additional freeze-thaw deterioration. Earth backfill, the most economical method of providing insulation, was not feasible in all reaches because of buildings near the wall and other right-of-way restrictions. Consequently, a precast concrete panel system that included insulation and drainage provisions was selected for the repair (Figure 8-49).

(4) A 10-mil-thick polyethylene vapor barrier was placed on the existing wall surface; deteriorated concrete was not removed prior to the repair. A 51-mm (2-in.) thickness of extruded insulation was placed on the vapor barrier. The insulation was then covered with another polyethylene vapor barrier. A crane was then used to lift the panels from the horizontal beds to the wall. The panels were positioned so that the groove accommodated the waterstop from the adjacent panel. Expansion-joint material was placed between the panels, and nonshrink grout was placed in the groove to encapsulate the waterstop. A cast-in-place concrete cap on top of the precast panels minimizes moisture intrusion into the repair.

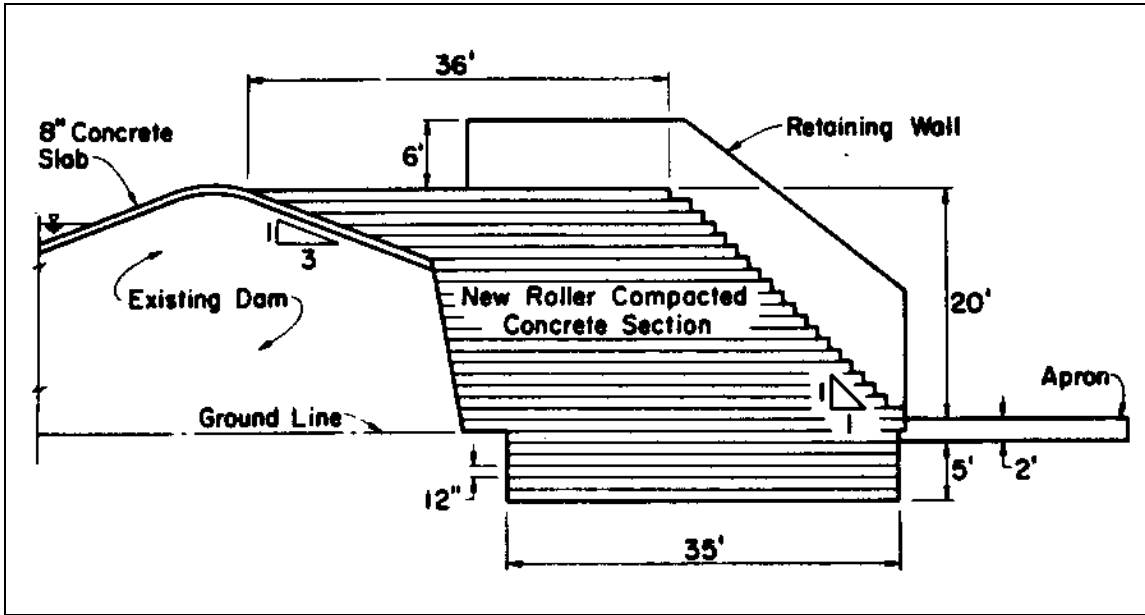
Figure 8-66. RCC gravity section, Kerrville Ponding Dam (Hansen and France 1986)

d. Kerrville Ponding Dam. The dam consists of a compacted clay embankment 6.4 m (21 ft) high and 182 m (598 ft) long with a 203-mm (8-in.)-thick reinforced concrete cap. The dam, located on the Guadalupe River at Kerrville, TX, was completed in 1980. A service spillway to handle normal flows was created by lowering a 60-m (198-ft) section of the dam 0.3 m (1 ft). The entire dam was designed to be overtopped during flood condition; however, the dam sustained some damage when overtopped in 1981 and 1982. The worst overtopping, 3 m (10 ft) on New Year's Eve, 1984, damaged both the embankment and concrete cap on the downstream slope. The majority of the damage was to the service spillway where about 40 percent of the concrete facing was lost along with a significant portion of the embankment.

(1) After several repair alternatives were evaluated, the fastest and most practical solution was to construct an RCC section immediately downstream of the dam (Figure 8-66). The downstream portion of the embankment was removed; the undamaged upstream portion acted as a cofferdam during construction of the RCC section. An 89-mm (3.5-in.) maximum size pit-run aggregate with 10 percent cement by dry weight was used at the base of the dam and in the last five 0.3-m (1-ft)-thick lifts. Cement content was reduced to 5 percent for the middle of the gravity section. The average compressive strength of the richer RCC mixture was 14.5 MPa (2,100 psi) at 28 days. Placement of the 17,140 cu m (22,420 cu yd) of RCC began in late June 1985 and was completed in about 3 months.

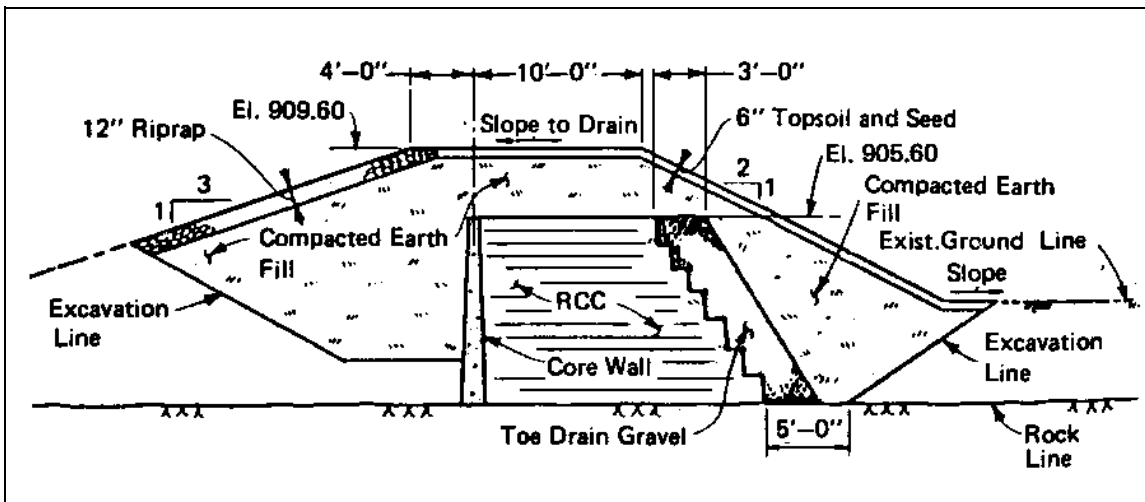
(1) In 1986, it was determined that the original spillways were not adequate to pass the Probable Maximum Flood (PMF) under present-day dam safety criteria. After studying several alternatives, it was concluded that RCC overtopping protection for 305 m (1,000 ft) of the left embankment would be the least costly plan for increasing spillway capacity (Marold 1992). This plan was eventually modified so that an RCC gravity section would be placed immediately behind an existing concrete core wall in the embankment. This modification reduced the length of the RCC spillway section to 152 m (500 ft). The shorter length required the crest of the RCC gravity section to be lower to pass the same flow as the longer paved section. Therefore, the crest of the new RCC gravity section was set at 0.3 m (1 ft) below normal pool and a 1.2-m (4-ft)-thick fuse plug of erodible earthfill was placed on top of the RCC (Figure 8-67).

Figure 8-67. RCC spillway section, Boney Falls Dam (Marold 1992)

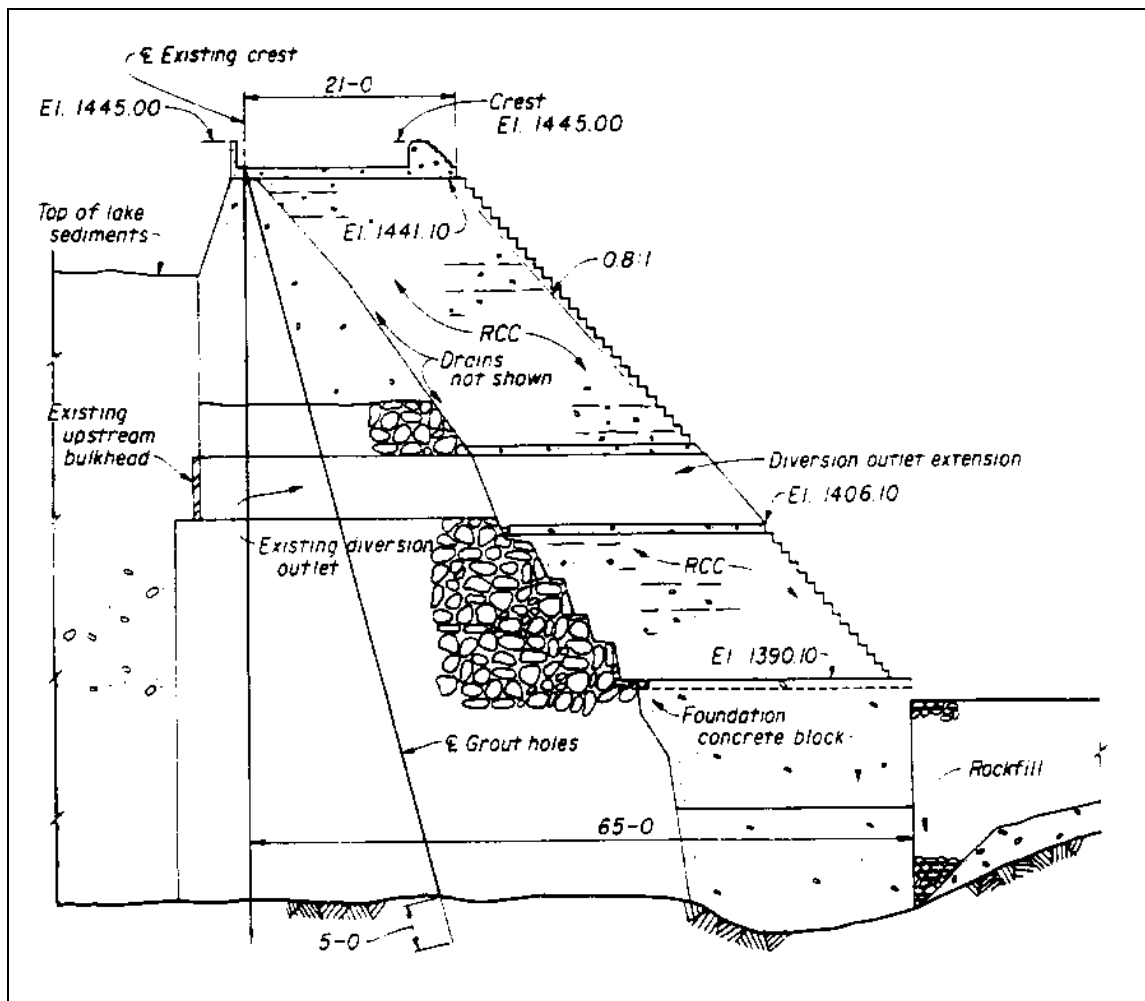
downstream slope of 8H:1V. However, in the final design, the width was increased to 6.1 m (20 ft) to accommodate two lanes of construction traffic on the RCC lifts. The RCC buttresses were capped with a conventional reinforced-concrete apron and ogee overflow crest (Figure 8-68).

Figure 8-68. Cross section of modifications for Camp Dyer Diversion Dam (Hepler 1992)

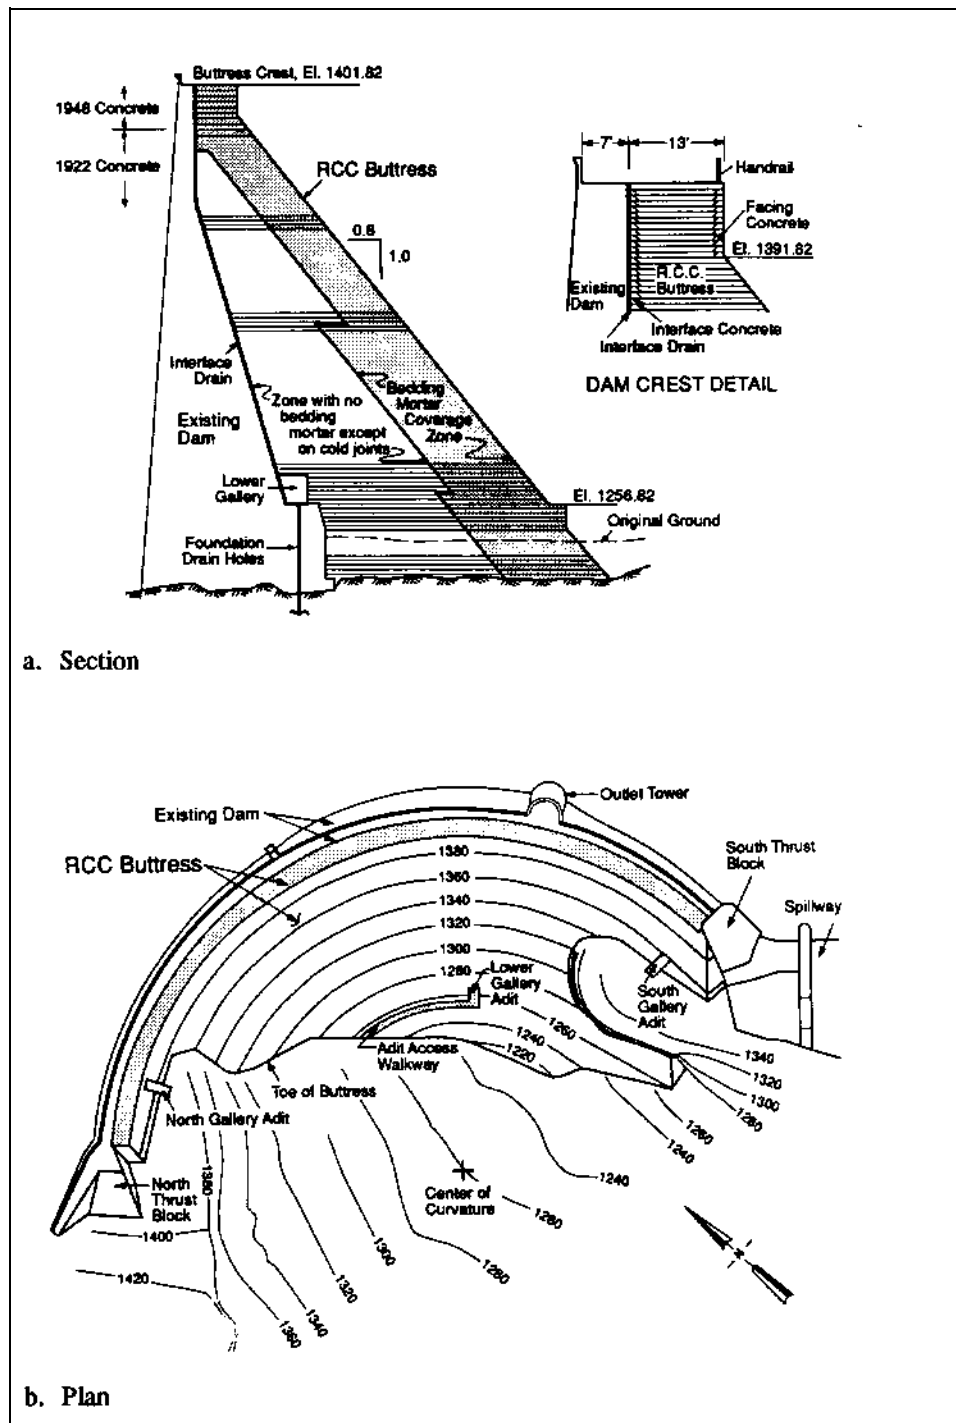
(1) The results of a 1983 safety evaluation indicated that the dam did not meet seismic safety standards. Therefore, an RCC buttress was constructed against the downstream face of the dam to alter the dynamic response characteristics of the dam and thus reduce the stresses induced during an earthquake. The addition of the gravity buttress effectively converted the existing arch into a curved gravity dam as shown in Figure 8-69 (Wong et al. 1992).

Figure 8-69. Section and plan of modified Gibraltar Dam (Wong et al 1992)

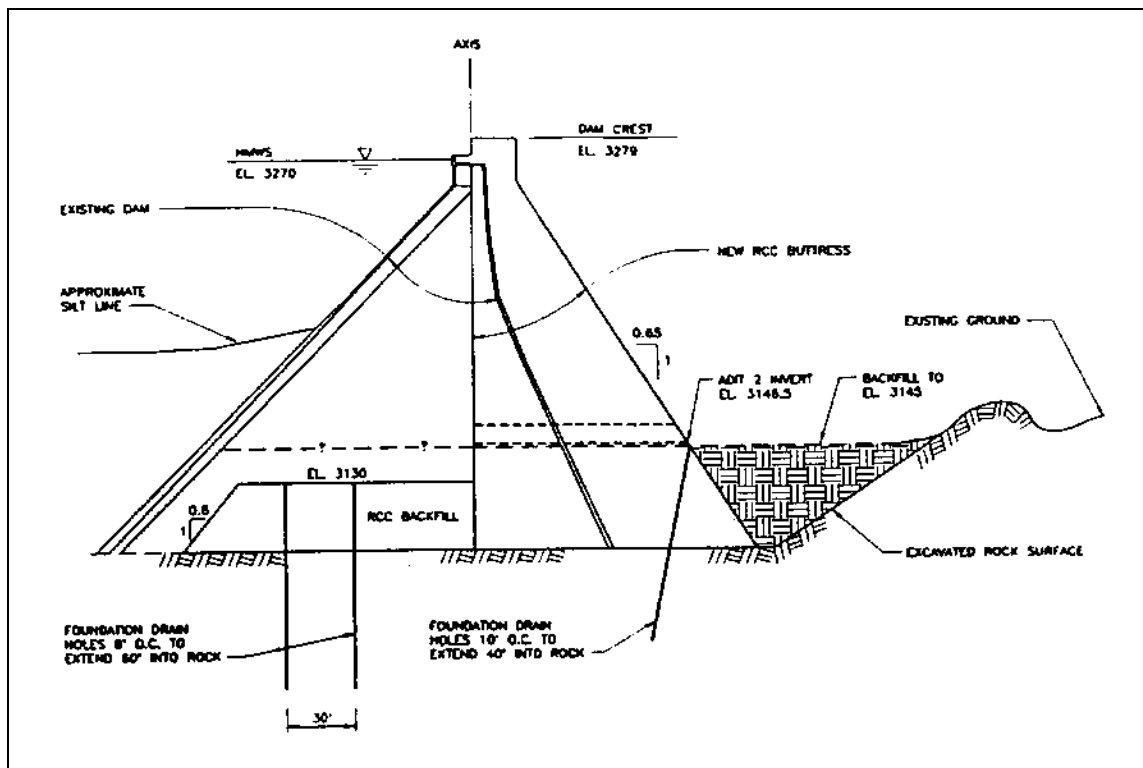
rehabilitation program that included construction of an RCC gravity section between and around the downstream portions of the existing buttresses (Figure 8-70). Also, steel fiber-reinforced shotcrete with silica fume was used to resurface and stiffen the arches of the existing dam. RCC placement began in November 1993, and approximately 70,500 cu m (93,000 cu yd) was placed in just over 2 months. The RCC essentially converted the multiple-arch dam into a gravity structure. In addition, the crest of the dam was raised 3.7 m (12 ft) with conventional concrete to increase water storage capacity. The cost of the RCC buttress repair was \$12.8 million compared to an estimated cost of \$22.5 million for filling the arch bays with mass concrete.

(2) When the Northridge earthquake shook southern California in January 1994, the RCC placement was within 5 m (16 ft) of the crest of the existing dam. Although there was widespread damage to highway bridges within 56 km (35 mi) of the project, the quake had no noticeable impact on the dam.

Figure 8-70. Littlerock Dam modification (Bischoff and Obermeyer 1993)
